KENNEBECASIS WATERSHED RESTORATION COMMITTEE

Restoration Site Portfolio

1995-2017

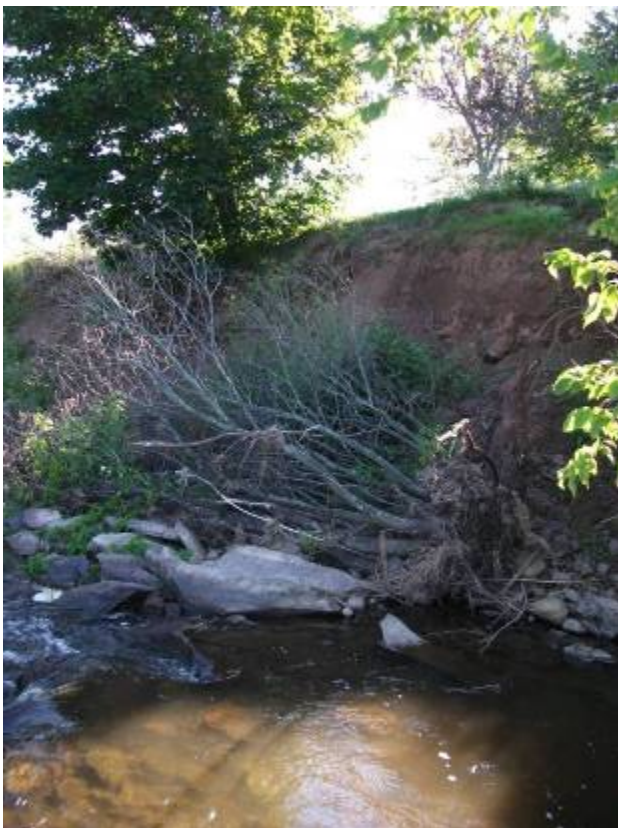
With work being completed above this farm site it was important that the Kennebecasis Watershed Restoration Committee (KWRC) work to also protect and enhance this farm site. With a long, severely eroding, and in places very high, stream bank that has been on our priority issue list for sometime it was rewarding to complete this site in 2011. The farmer had already been fencing his cattle away from this stream bank but with available resources the KWRC stabilized a 95m section of stream bank, installed 5 rock groynes to improve fish habitat, and planted a number of trees to improve site biodiversity and improve riparian zone health. During our fish rescue efforts, before construction, staff discovered a burbot. This was the first time it had been seen in Ward's Creek.

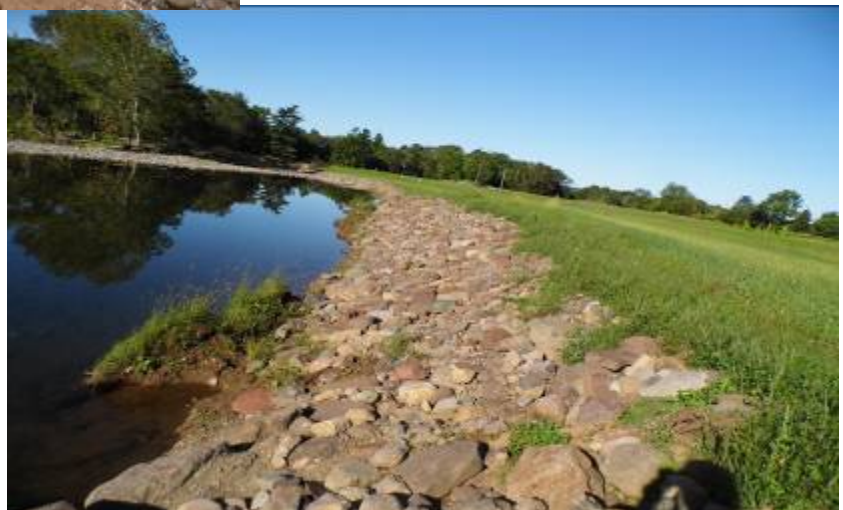
The KRWC began consultation with the landowner in 2013 to potentially restore an eroded bank. After the spring of 2014, the landowner lost a considerable amount of land after the stream broke its right bank and formed a new channel through the eroded area into the adjacent field. The KWRC decided to use rock armour to stabilize the 70 m bank, and instead of fixing the channel, they chose to let the stream run its new course and restored the surrounding land and planted 570 trees, 6 of which were calliper trees, as well as planting willow stakes. The design of the site has been created so that there are any major floods, the water will come up and be negated by the slope of the bank.

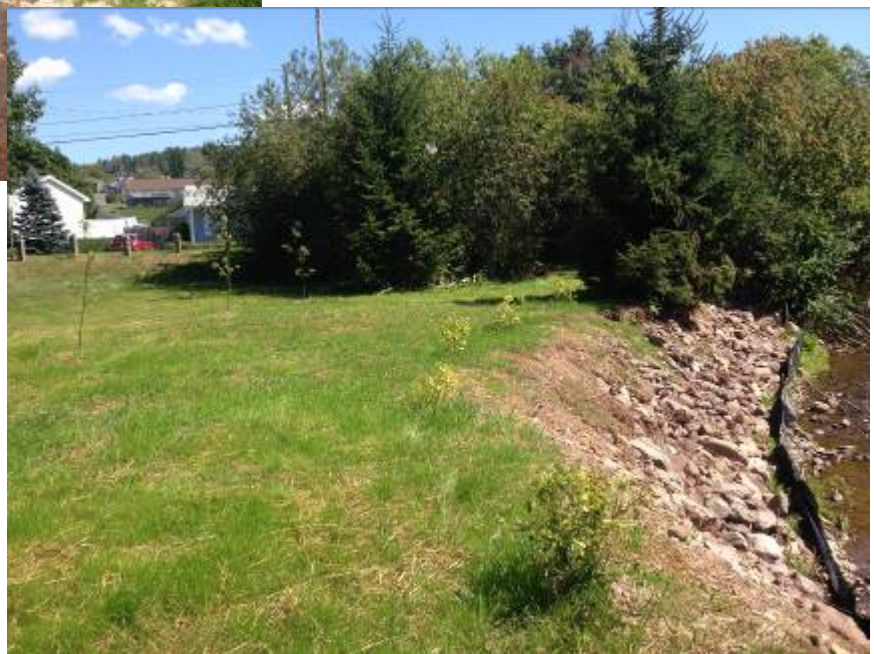
The landowner at this location was continuously losing parts of his property to erosion each year during spring flush. This 22m long bank was back sloped to improve floodplain connectivity and rock armoured to prevent further erosion. Rock kickers were installed on the upper and lower end of the bank to mitigate possible changes in hydraulic flow. Trees and shrubs were planted within a 5m buffer zone along the banks riparian zone, this included 6 service berry shrubs and 4 caliper stock red oak. Willow stakes were also planted along the toe of the bank, 345 in total.

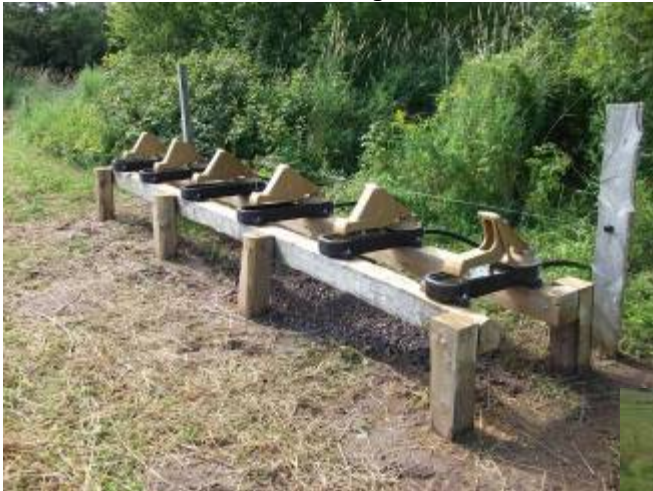
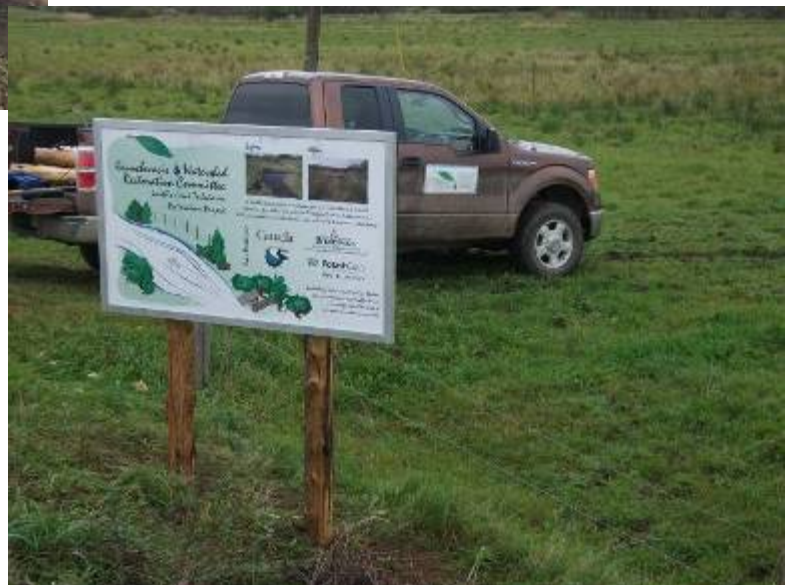
A small tributary to the Smith's Creek was being choked with sediment and lacked the natural habitat functions of a healthy stream. To improve grazing and farming conditions on this property and to enhance riparian and aquatic habitat the KWRC suggested a number of tasks be undertaken. Cattle were fenced away from the riparian zones for the entire field and a bank of six nose pumps were installed for water. A degraded culvert was replaced to improve stream hydraulics and various trees were planted along the stream to improve bank stability and add site biodiversity. Future work on this site may be needed to improve natural flow conditions which are being hampered by high sediment deposition along this low gradient stream section. It may be necessary to remove woody debris from the channel in order to attain a more natural flow pattern.

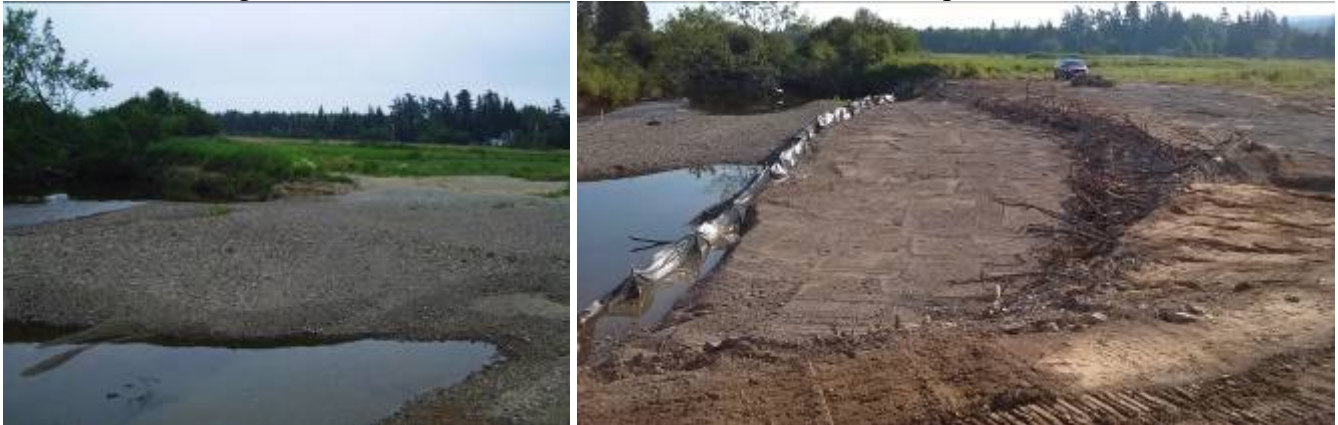
This site resulted from a flood event that started to form a flood channel and deposition area in the field. We reshaped and stabilized the bank using tree revetments.

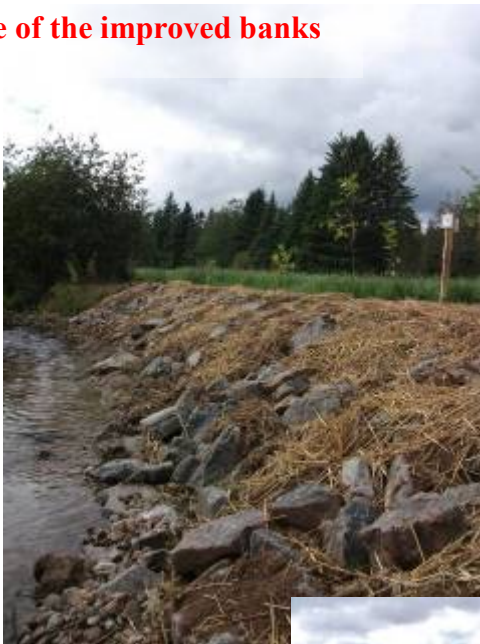
One of the improved banks

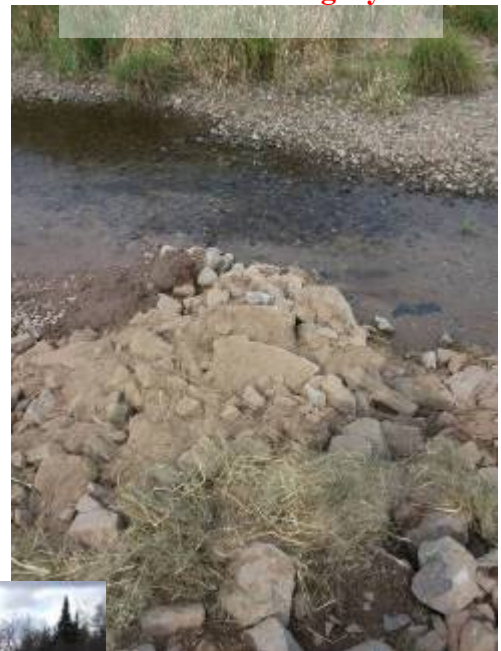
An installed rock groyne

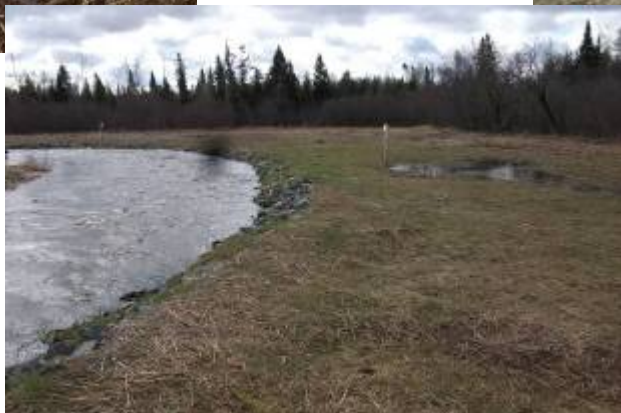
Lower bank under high water conditions

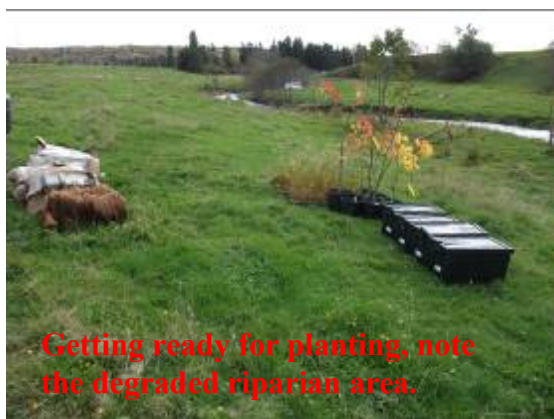
Getting ready for planting, note the degraded riparian area.

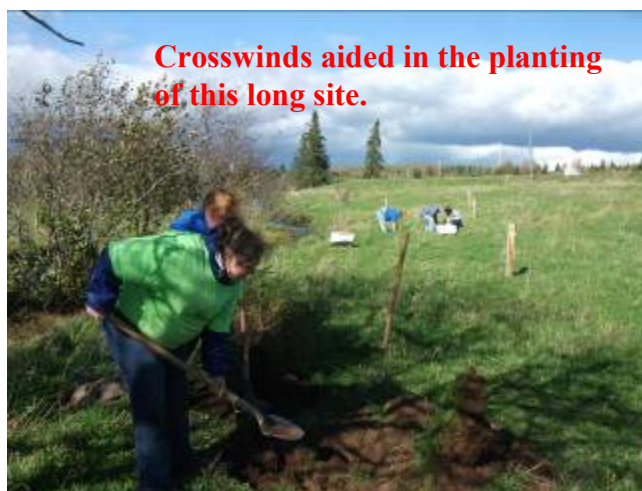
Crosswinds aided in the planting of this long site.

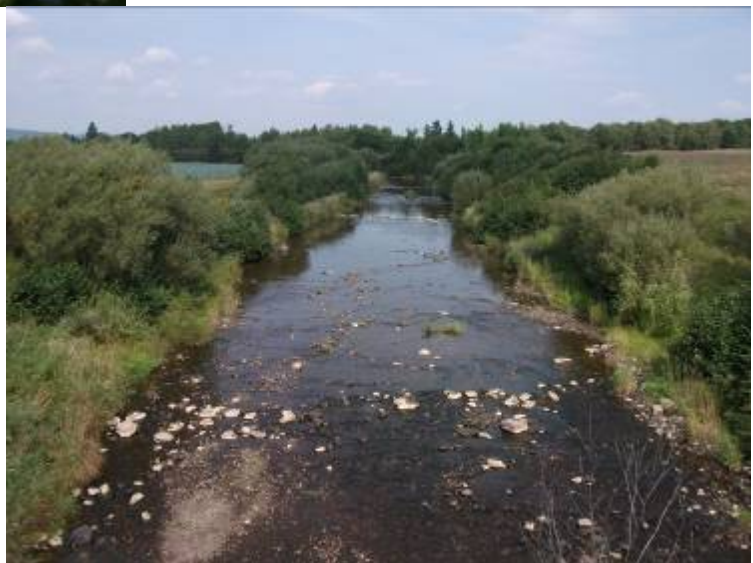
The Berwick Corner site in 2010.

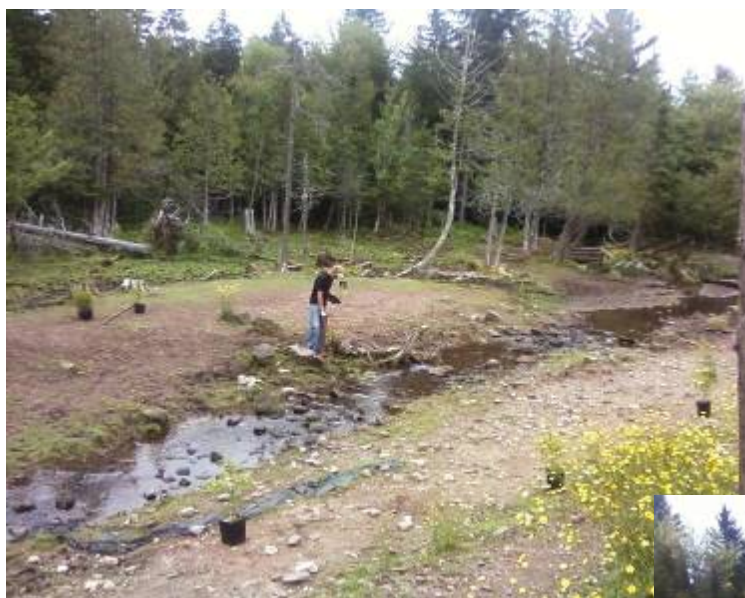
Crews planted seedlings and spread triple mix grass seed to enhance the site.

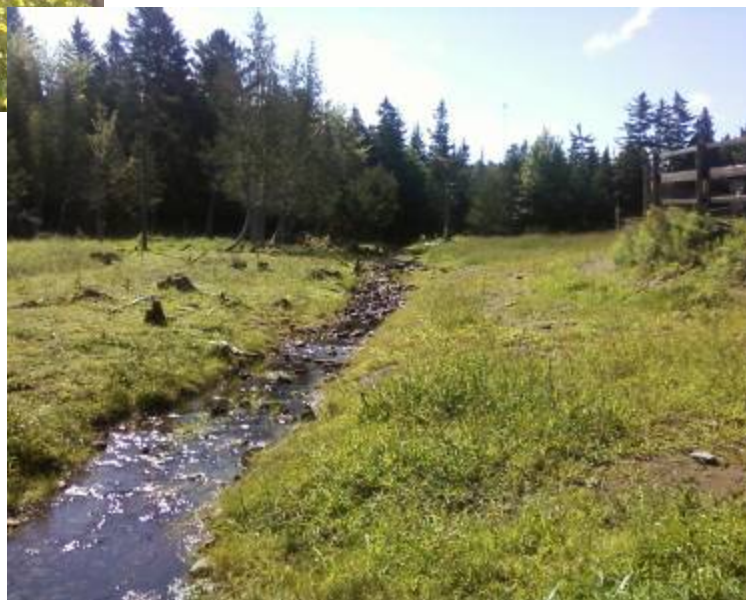
Through one season, the difference in site aesthetics and ecological integrity is astounding.
